Manhole Inspection Summary

Manhole # S47GG_036MH

Insp Date: **6/17/08 9:59 AM**

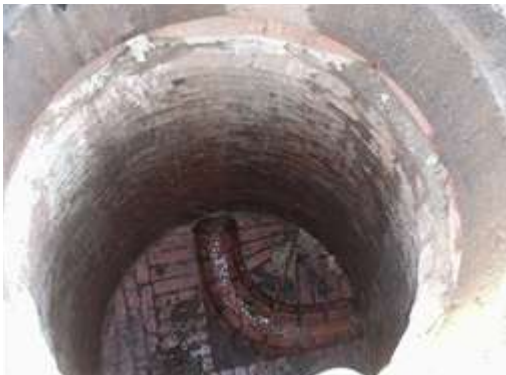
Defect 2

Infiltration: ☐ None ☐ Joint ☐ Cracks ☐ Mortar ☐ Roots ☒ **Wall**

infiltration

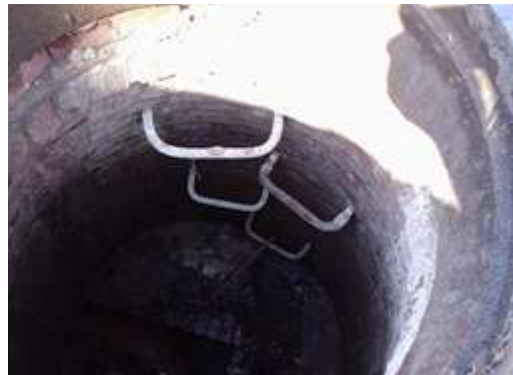
Defect 1

loose bricks

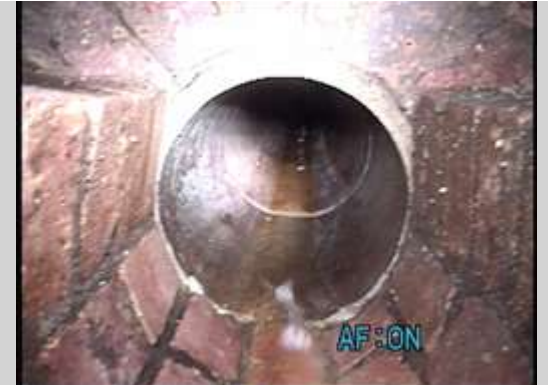
12 O'Clock Outflow

8 in. Circular Gravity Sewer
Pipe Out @ 12 O'Clock

Pipe Height: **8.4** (in.) Rod and Bar (Angled)
Pipe Material: **Clay** ☐ Pipe Lined
Invert Depth: **8.30** (ft.) Flow Characteristics: **Fast**
Deposits: ☒ None ☐ Mud ☐ Sludge ☐ Debris ☐ Grease
Silt Depth: (in.) Deposits Extent:
Infiltration: **None** Pipe Seal Cond: **Sound**

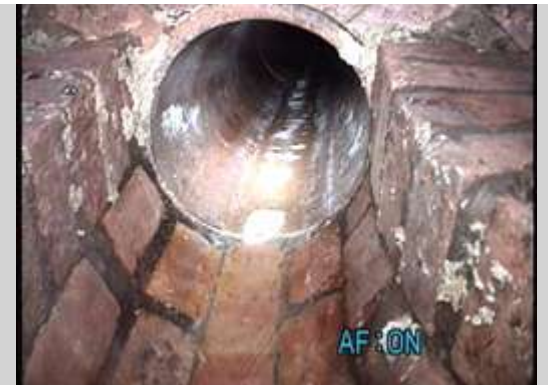
9 O'Clock Inflow

8 in. Circular Gravity Sewer
Pipe In @ 9 O'Clock

Pipe Height: **8.4** (in.) Rod and Bar (Angled)
Pipe Material: **Clay** ☐ Pipe Lined
Invert Depth: **7.90** (ft.) Flow Characteristics: **Fast**
Deposits: ☒ None ☐ Mud ☐ Sludge ☐ Debris ☐ Grease
Silt Depth: (in.) Deposits Extent:
Infiltration: **None** Pipe Seal Cond: **Sound**
